Advisory Visit

River Wharfe, Bradford City Angling Association

05/01/2017

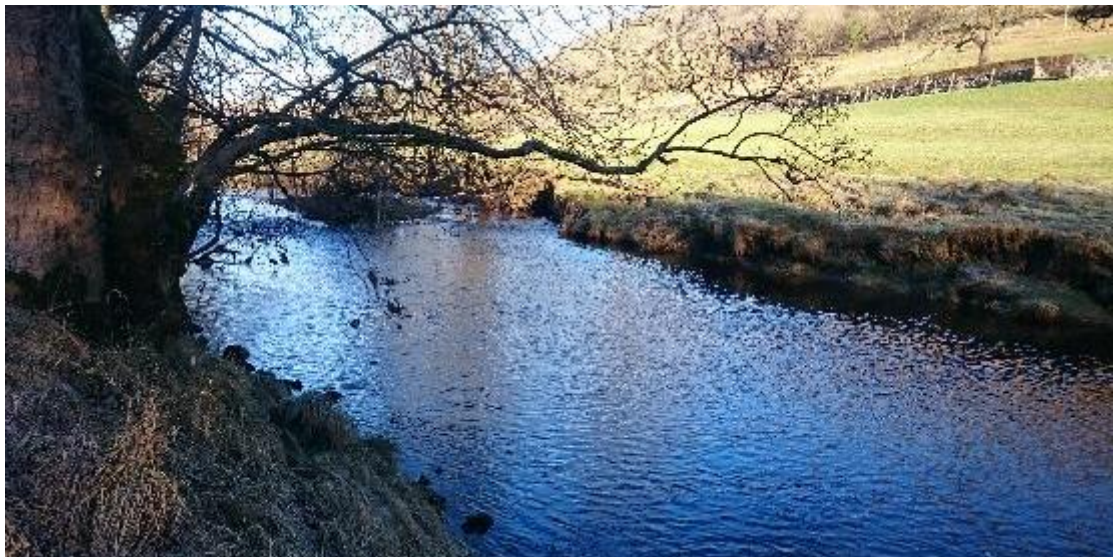
Fig 1. Typical banking, with scattered mature alder trees on the true right bank. Note the lack of cover on the left bank where livestock access (sheep) has reduced the riparian vegetation to a short sward of grasses.

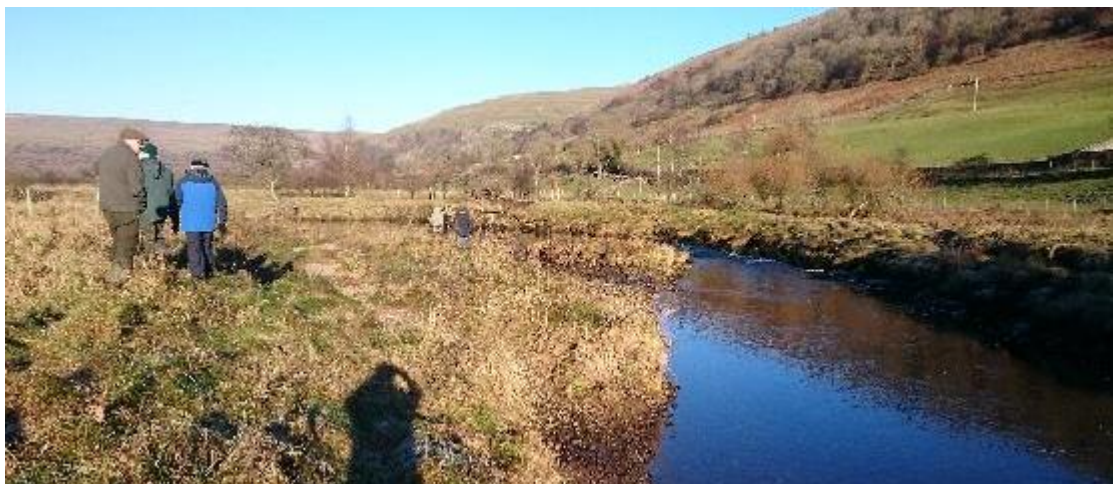
Fig 2. Area of deposition on the inside of a bend leaving a good width of buffer zone, ideal for planting of trees. The LB is rock armoured here; the sinuous channel has good variability in water depth but lacks riparian cover (and shade), greatly reducing its fish-holding capacity.

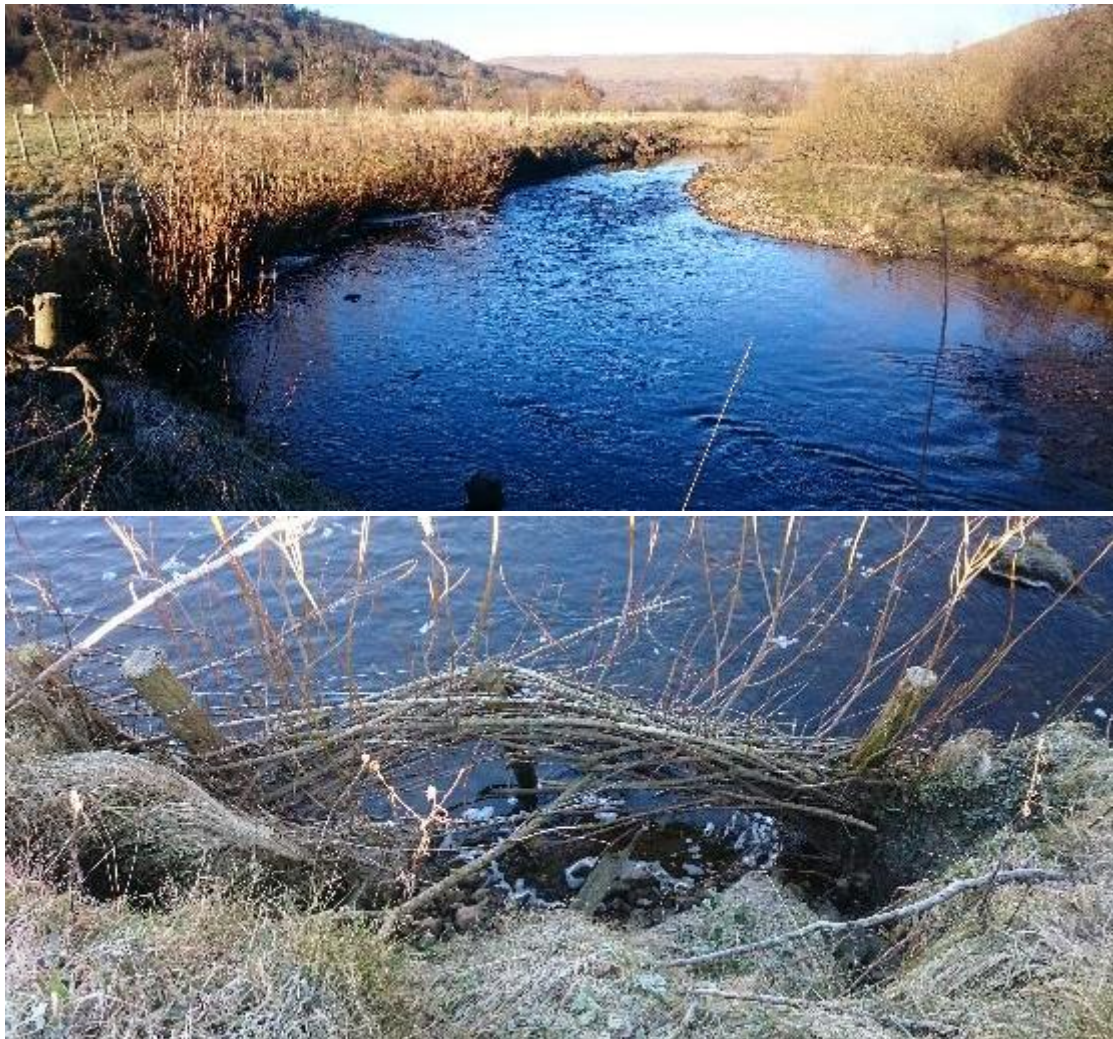
Fig 3. A short section of willow spiling to reduce erosion scour on the RB (upper). While this has started to grow and the roots will help retain the structure, the tail end of the spiling has been undermined by flow and scour is beginning again (lower). The hole should be packed with living willow brash and wired into position, continuing the brash ~2m further d/s to prevent re-occurrence. Living willow whips inserted through the spiling at the waterline and from the river side will help soften the force of the water working against the spiling. The roughness and diffuse nature of brash often makes it more applicable than willow spiling for bank protection work on upland rivers.

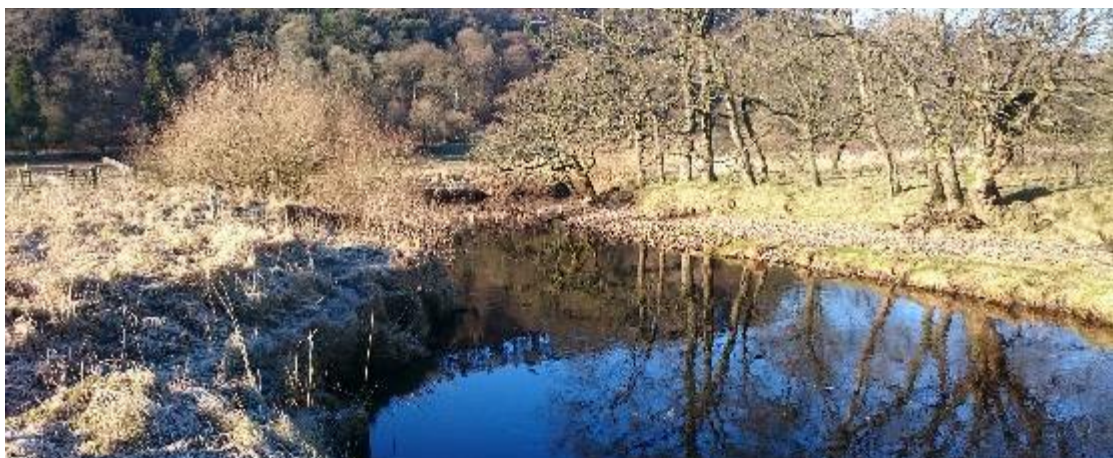
Fig 4. The lower sections offer good riffle, glide and pool sequences. Better cover could be achieved by laying some of the more mature goat willow stems over the water at a downstream angle ($<30^\circ$ to the bank) so that the branches are touching the surface. Willow whip planting at strategic locations is a cheap, quick and easy method of establishing low cover; whips can be sourced from the bank side of the larger established willows, ensuring not to take the valuable riverside/trailing cover.

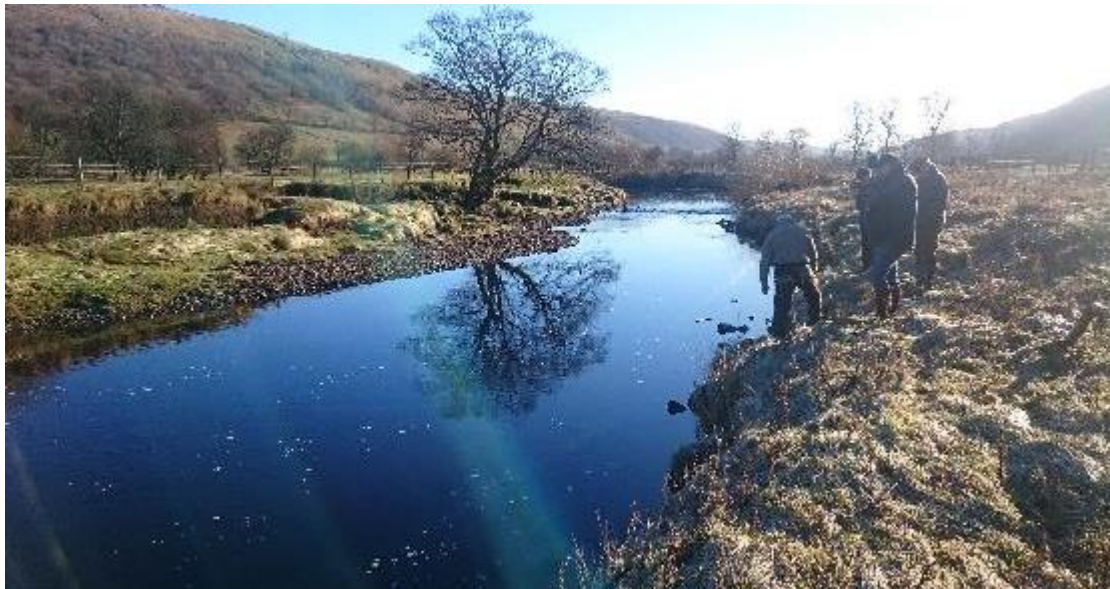
Fig 5. The d/s end of a very long straightened section (about mid-way along the lower Buckden length) where armouring on both banks is obvious. The armouring and associated drystone wall have failed in several locations and introduced large boulders which bounce the water flow away from the edge, actually introducing some sinuosity at low flows. This could be encouraged in further locations. The banks require some willow whip planting as there is a distinct lack of cover. NB: mink tracks were observed here.

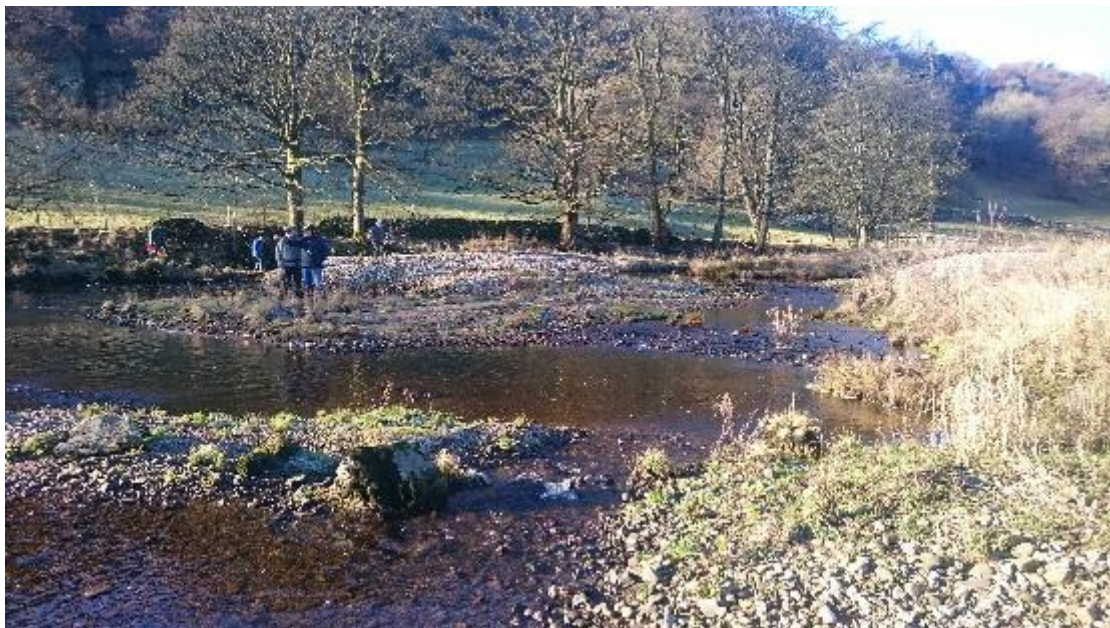
Fig 6. An interesting area of braiding as the river weaves in multiple channels across an enormous deposition of cobble and gravel. There were some good patches of salmonid spawning-sized gravels deposited here, and the diversity of flows and pockets of deeper water offer refuge habitat for juveniles. Some brash bundles could be pinned in the more protected pools to further enhance fry and juvenile refugia. Colonisation of the exposed bars by shrubby vegetation could be augmented with some willow whips to provide low cover.

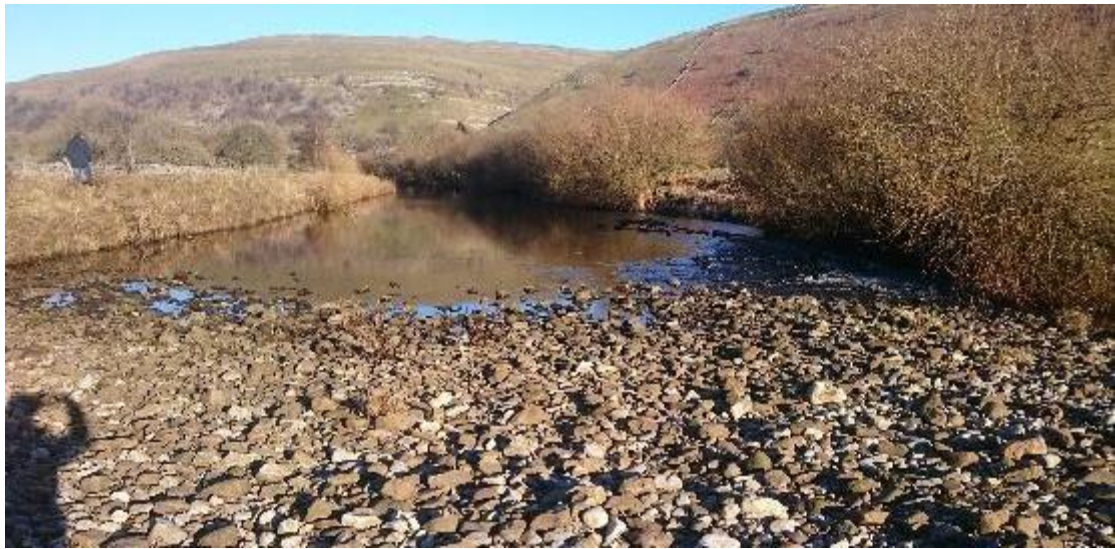
Fig 7. The d/s end of another long straightened section that ends abruptly in the enormous cobble deposition (RHS of Fig 6) that has blocked the channel and impounded the water for ~100m u/s. The majority of water now slews to the left (see Fig 8).

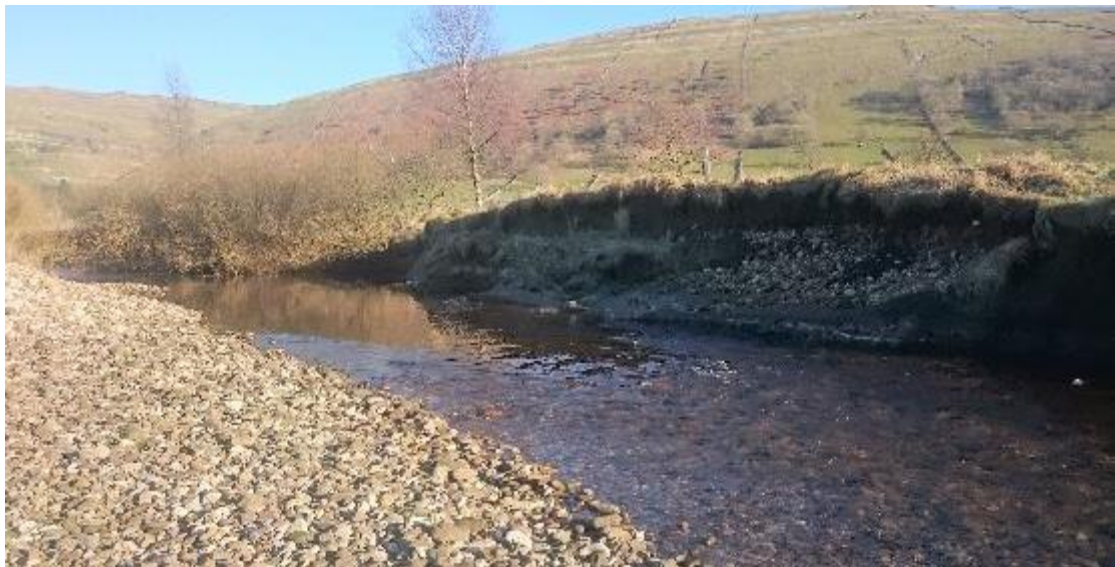
Fig 8. Erosion scour of the LB caused by the redirection of the main flow around the deposition bar (Fig 7). Leave this to allow the river to naturally restore sinuosity.

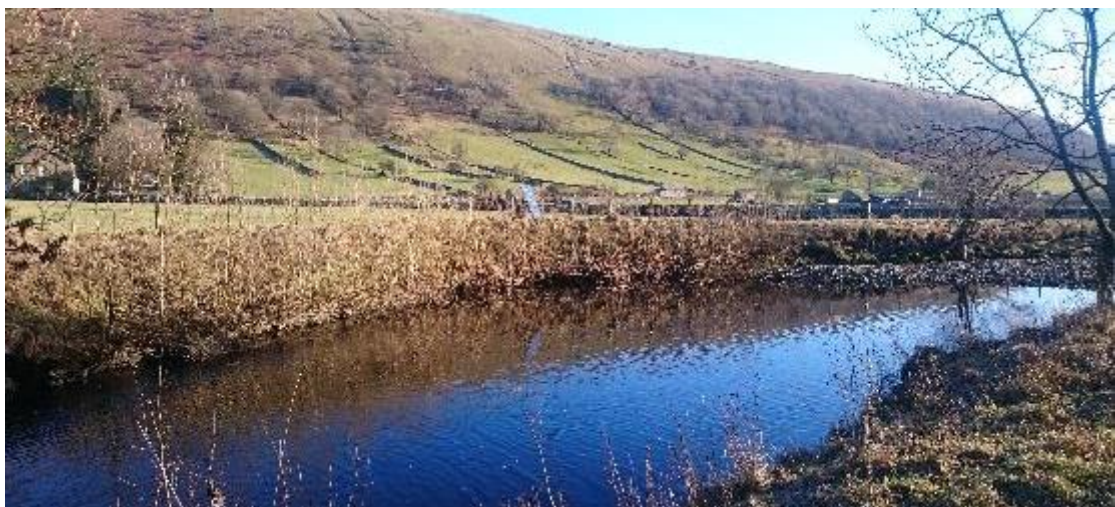
Fig 9. Another section of willow spiling on the LB that appears to be intact, functional and alive. Some of the taller stems could be laid d/s to provide low cover. NB: mid picture is a solar panel providing power for a drinking trough.

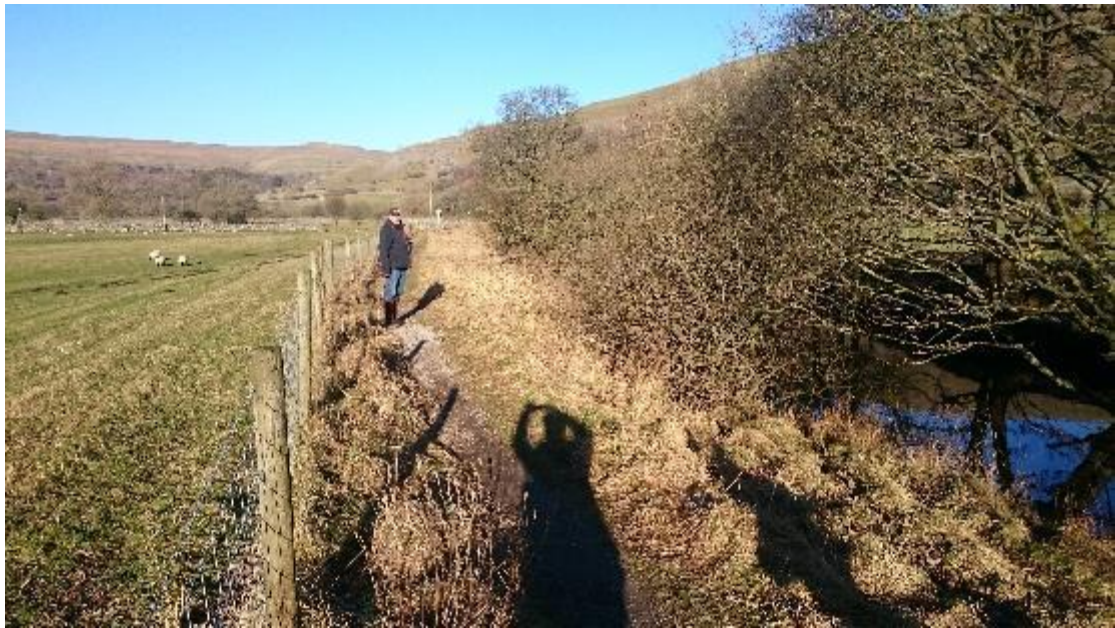
Fig 10. The Dales Way is reasonably screened from the river by dense, shrubby hawthorn and willow. However, these do not appear to provide any low cover on the river side, and some trunks should be laid over the water.

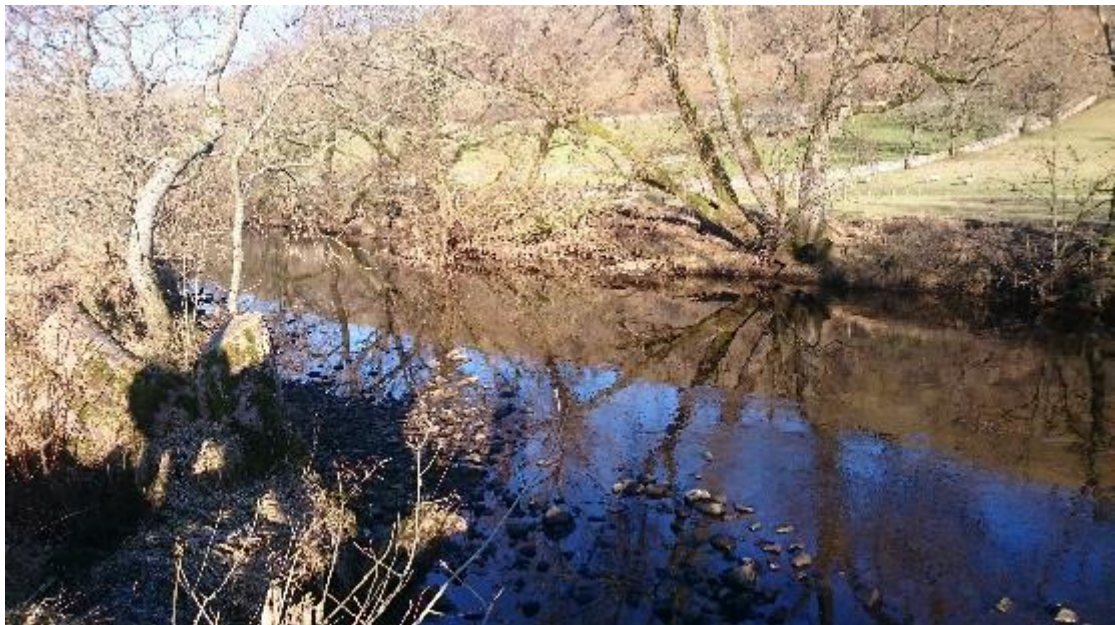
Fig 11. Mature ash and alder lining both banks of the upper Buckden length. Natural introduction of woody material has created favourable holding habitat. There are relatively natural pool-riffle-glide sequences.

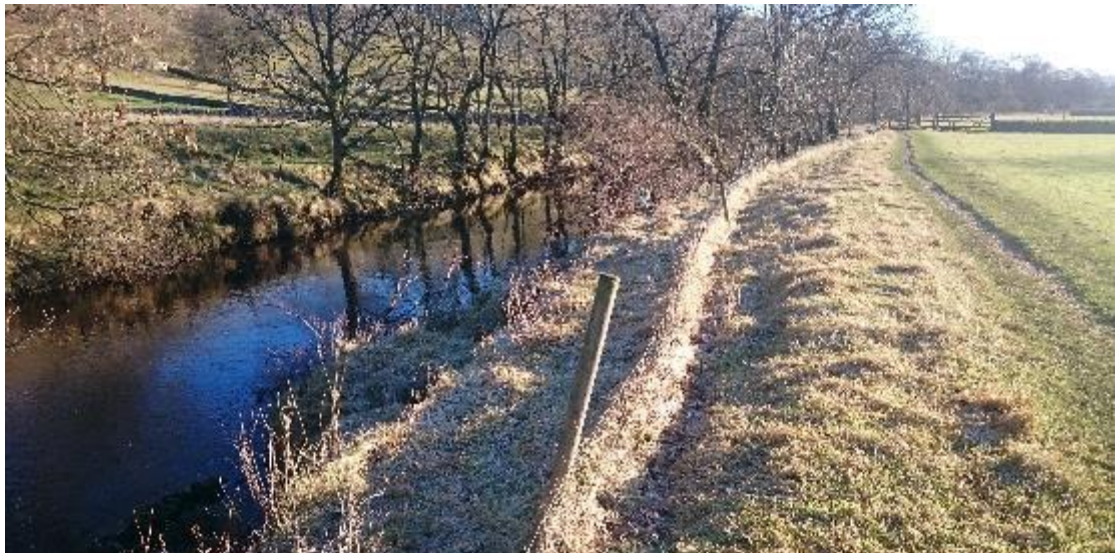
Fig 12. Consider reinstating this fence line as a priority to protect the bank from grazing, and discourage walkers from the adjacent Dales Way Path from disturbing the fish / fishing.

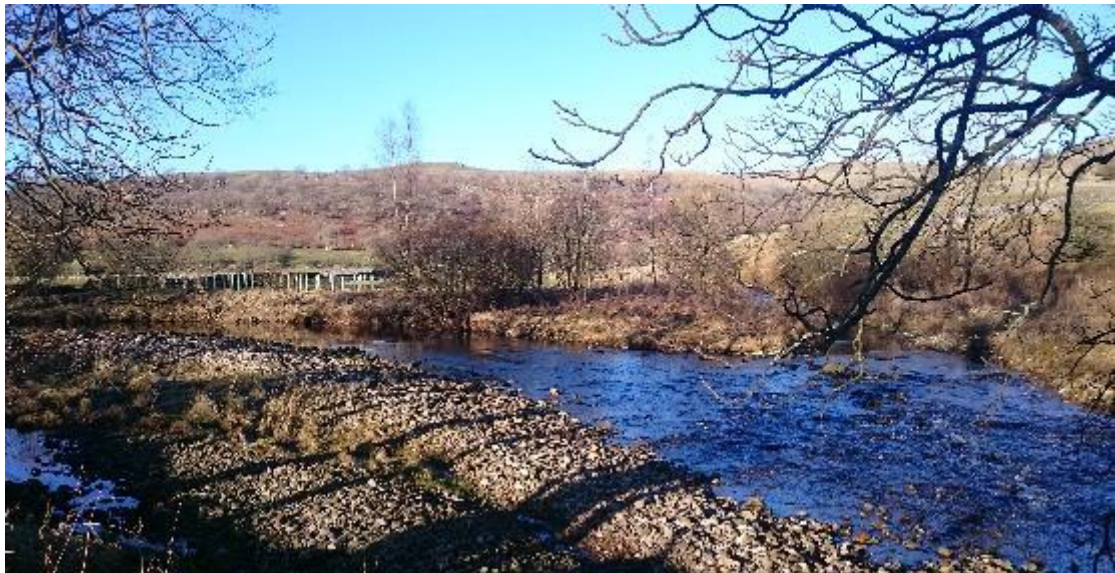
Fig 13. The confluence of Cray Ghyll with the Wharfe (LB). Yorkshire Dales RT & WTT have conducted instream and riparian habitat work along the lower 400m of Cray Ghyll. Tree sleeves can be seen toward the LHS of the image. The RB, from where the image was taken would benefit from further tree planting.

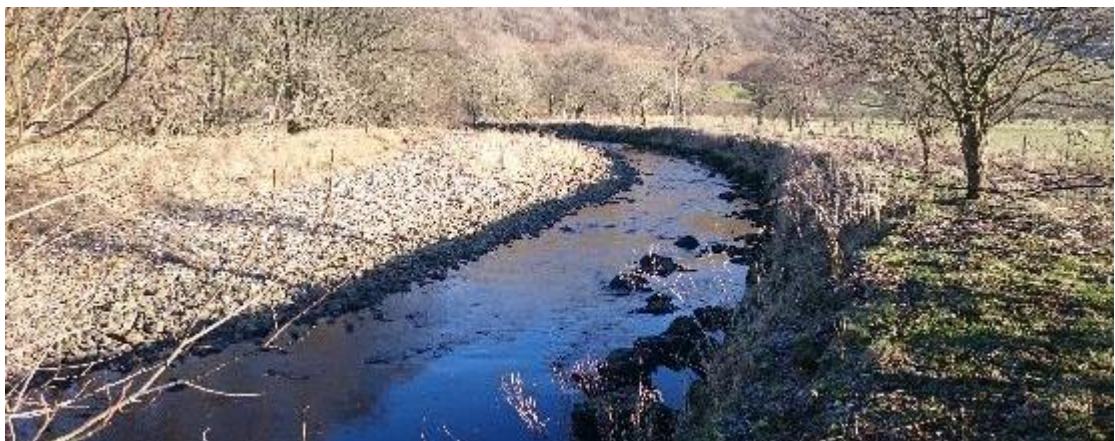
Fig 14. Long, sweeping bend resulting from channel realignment and rock armouring of the RB; devoid of cover, the RB would benefit from tree planting. These unnaturally long, sweeping bends tend to create elongated riffles and prevent pool formation.

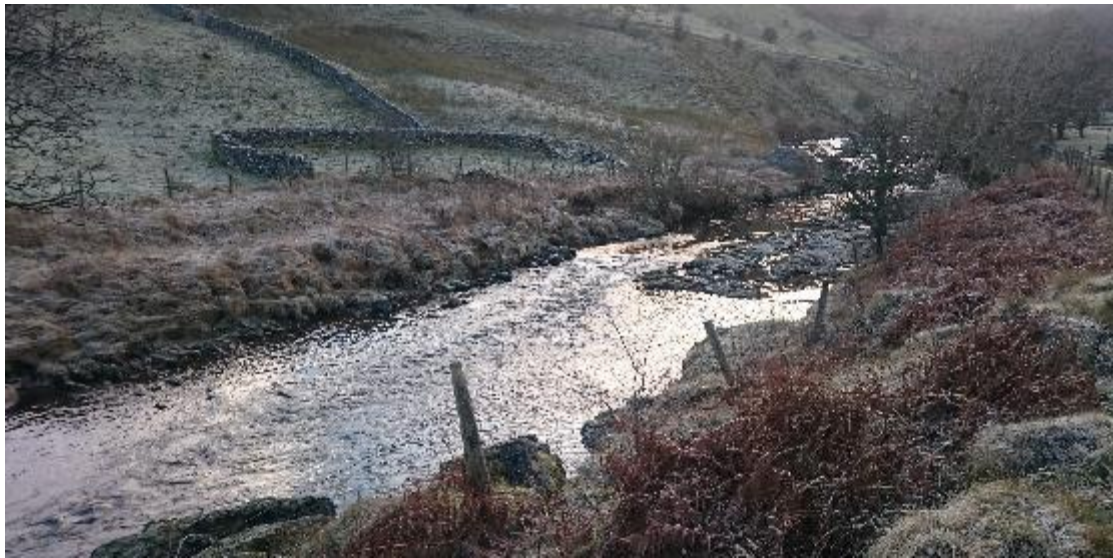
Fig 15. Channel heterogeneity increased by bedrock around the mid-point of the Hubberholme length. Fencing here is in poor condition and should be replaced. Cover is poor on the RB; willow whips should be inserted at the toe of the bank, and consider planting trees when the fence has been reinstated.

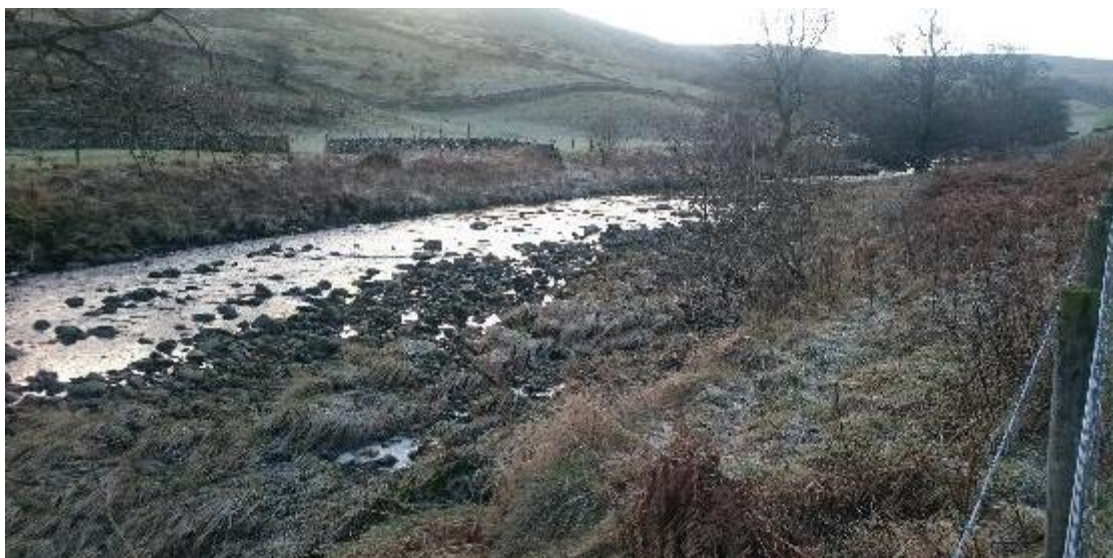
Fig 16. Scope for tree planting on the LB inside the good quality fence that borders the Dales Way.
